Hans Place

London SW5

The Red Brick and Stone design of 47 Hans Place, following the Arts & Crafts architectural style of Voysey & Macmurdo, was starting to show signs of wear in 2006. The expertise of C & D Restoration Limited was brought in to restore and stabilise the building façade whilst maintaining the integrity of the architecture.

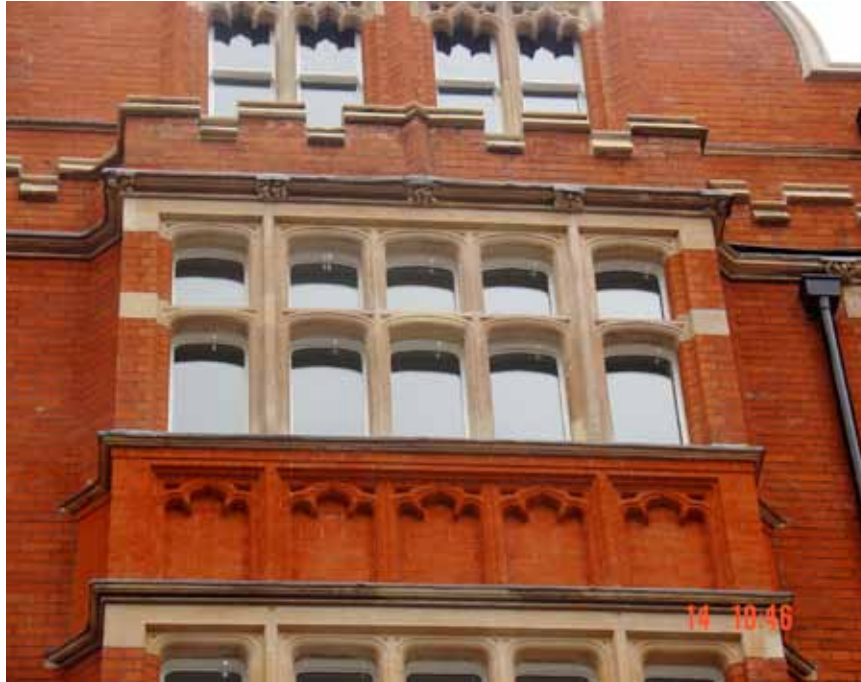
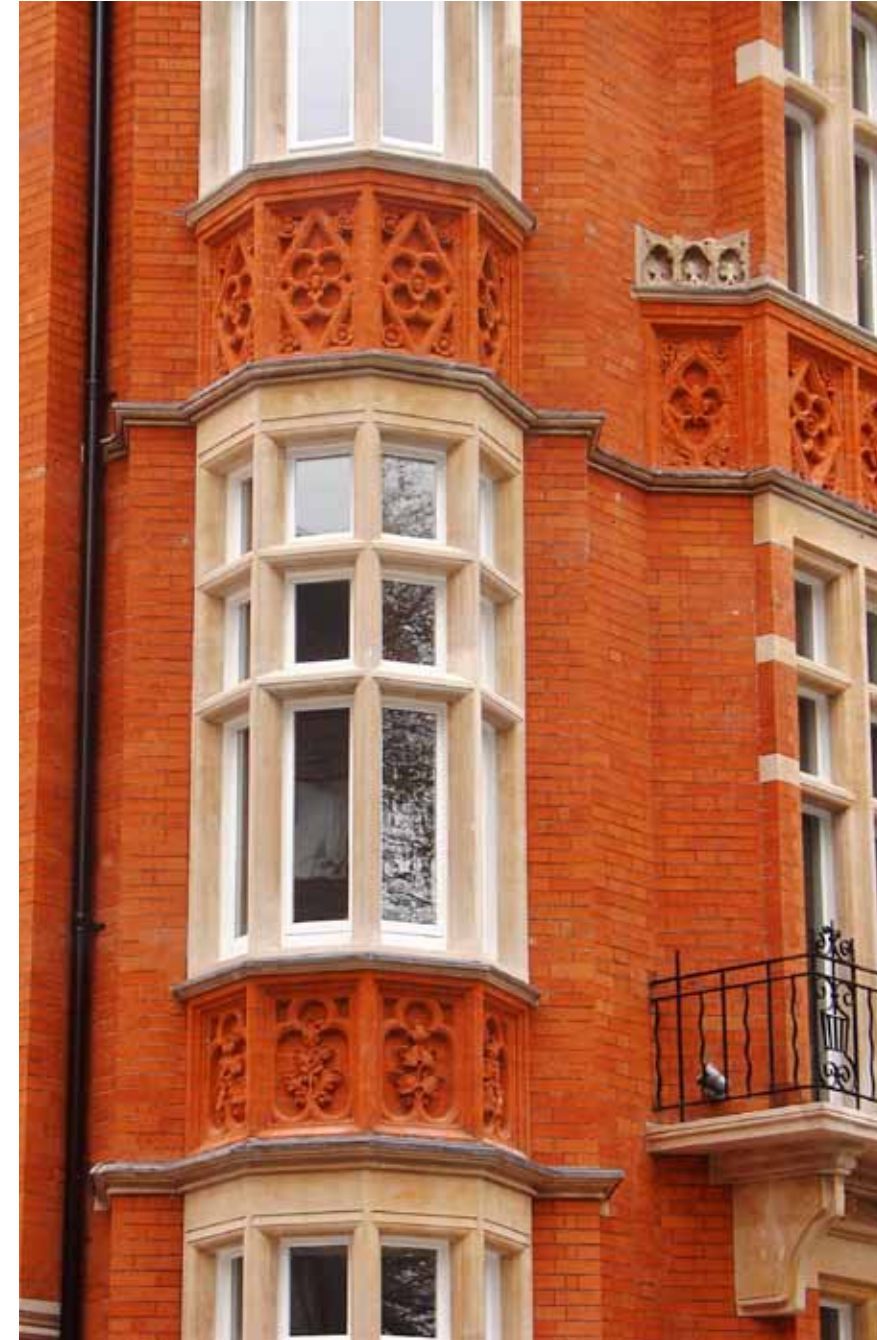
The fractured stonework was reinforced using stainless steel pinning and resin injection. Attention was then turned to the decorative moulded panels and cornices. A mild chemical solution was used in conjunction with the low pressure super heated DOFF system to strip paint from them, leaving them ready for repair.

We then applied our specialist techniques to carry out extensive stone repair on the following aspects of the building:

- The re-run of all string courses
- The fixing of Mullions and transoms
- The fixing of Coping stones, Mullions and Transoms.
- Moulded Cornices and Cross finials.

Also carried out was a full clean to the brickwork at both the front and rear of the property using the JOS/TORC cleaning system, and full restoration works to the first floor balcony. As with all of our projects, we ensured that only the highest quality of workmanship and materials were used to maintain the longevity and architectural character of the building.
