# 216-222 Old Brompton Road

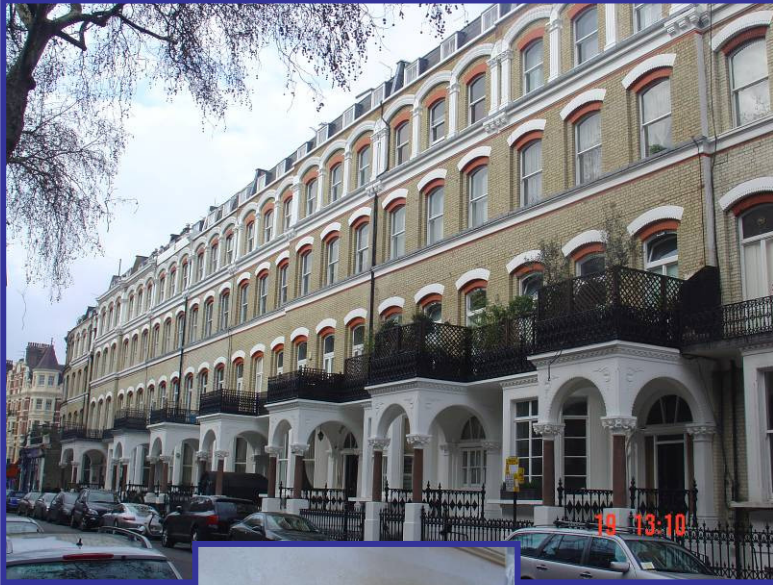
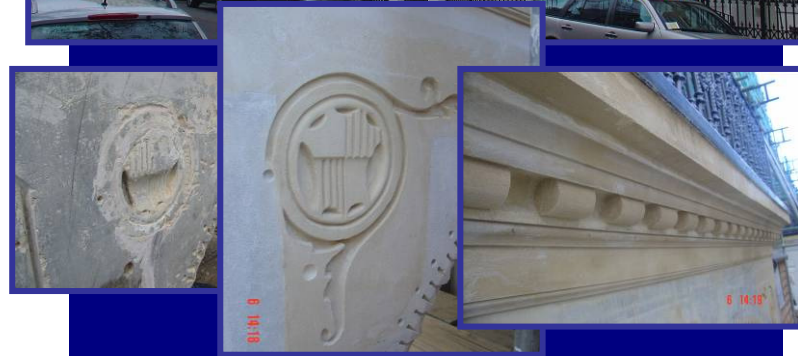
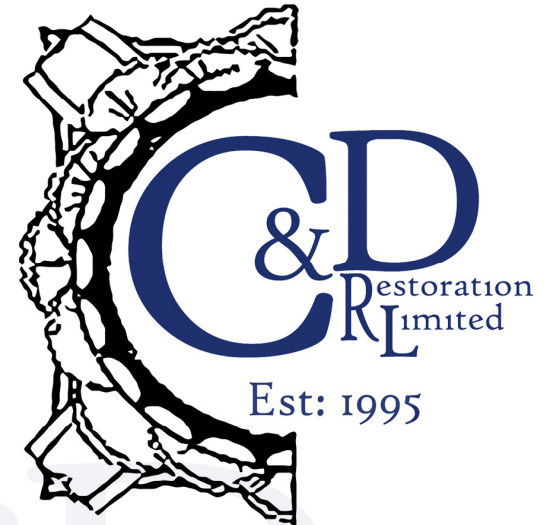
Extensive restoration works were carried out to the four painted, natural stone porticos. Paint was stripped from each portico using chemicals and the low pressure super heated DOFF system.

All moulds and profiles were cut back and restored by our team of craftsmen including all Corinthian capitals using bath stone mix.

Using skills honed over many years, C & D Restoration Limited undertook to repair and re-cast damaged floral capitals at the top of each of these columns.

Some of the stone mould designs on this building did not fit in with the architectural style of the surrounding properties. At the client's request, C & D Restoration Limited carried out a full inspection of the stonework and put their experience to work in developing a template which offered alternative portico design adjustments which could be incorporated to suit the aesthetic requirements. Our experienced craftsmen then worked to the template and re-worked the portico stonework accordingly.
